# **Mercantile Bank Buildings**

**302 West Main Street, Ionia Michigan**

## **Study of the Load Bearing Capacity of the First Floor**

**Project No. 201317**

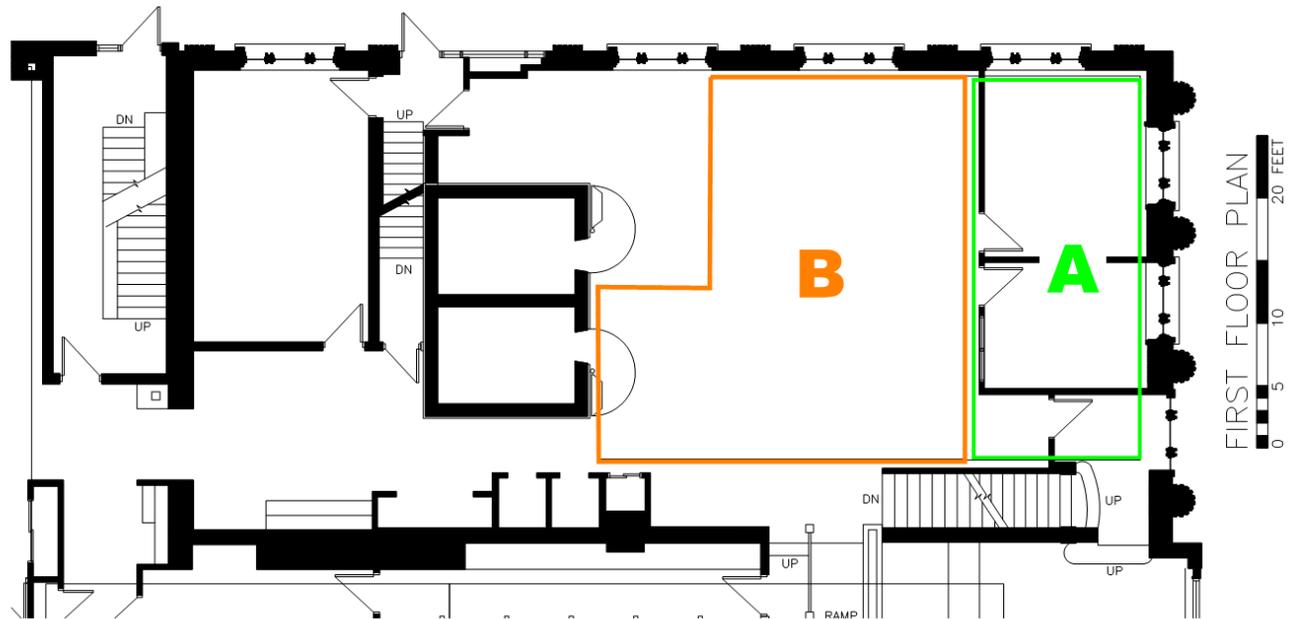
## East Building

The areas investigated in the East Building can be generally described as the portion of the building between the Vault and the front of the building. There are a series of rooms across the front (existing restrooms) that have plaster ceilings so the sizes of floor joist couldn't be determined, see Area A.

The rooms between the Restrooms and the Vault are unfinished spaces so the structure could be observed, see Area B. The floor joists are of adequate size and spacing. The existing support beams can stay in place. The new work would consist of providing new columns under the existing beams, centered between the existing columns. This cuts the beam spans in half.

There is also support missing above a doorway through a bearing wall. A new lintel would be installed there.

There is a notch out of Area B where the ceilings didn't allow observation of the structural system. Some selective demolition would be required to calculate what was required to reinforce that floor area.

With some selective demolition the size of the members above the ceilings could be determined. At the Women's Restroom and Lounge it's possible that beams could be slid across to bear on new columns tight to the sidewalls of the rooms. In that way the configuration of the rooms could be maintained with minimal architectural changes. At the Men's Restroom it's possible that the shorter span may be adequate without reinforcement, or a new intermediate beam could be added at the side wall of the room.

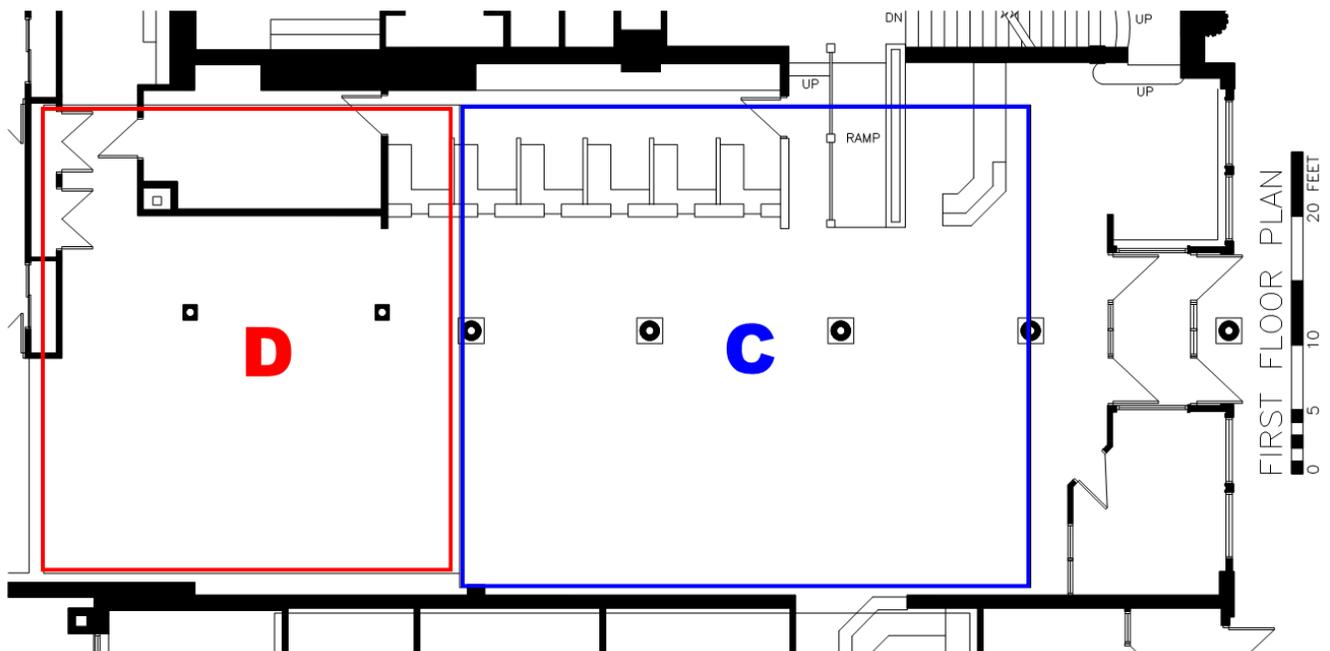
## Center Building

A large area running towards the south end of the Center Building has a single type of structural system with members that are fairly regularly sized and spaced, see Area C. The floor joists will be adequate if their span length is cut in half. This means running new beam lines and columns parallel with the existing center beam. A couple of new columns will also be required splitting the existing beam spans in half at specific locations under the existing center beam. And finally, multiple columns will be required wherever the regularity of the existing joist layout is interrupted.

The area between Area C and the south end of the building isn't being considered for reinforcement because it doesn't appear stacks would be located on this portion of the First Floor. Investigation of this area could be undertaken if the need arose, and there's no reason to believe the floor area couldn't be adequately reinforced.

Area D, at the north end of the Center Building has the most complicated first floor framing. It consists of floor joists of different sizes in different rooms, running in different directions and with varying bearing conditions. Nothing was discovered that would preclude reinforcement being able to be done. All of the specifics required to do so would be custom solutions calculated room to room, which is beyond the scope of this study.

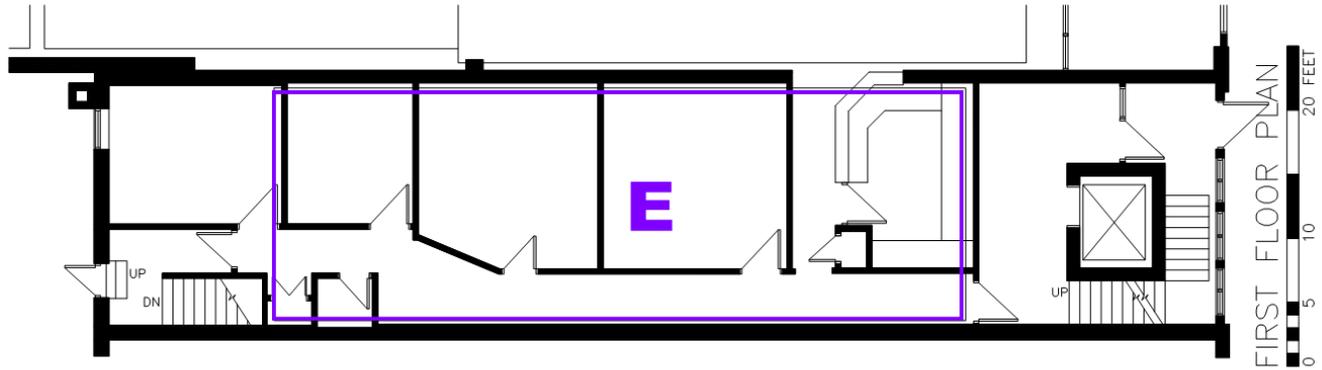
### West Building

The West Building, area E, has a plaster ceiling over its entire area, so learning about its structural system was a challenge. There was one hole that showed repetitive wood joists and it's clear they span the full width of the basement (about 18'). Based on that, there's a high degree of certainty that adding a beam with a line of columns down the center of the basement will provide the needed structural upgrade.
